**STILL BOTTOMS POND AREA FINAL ENGINEERED COVER
CONSTRUCTION COMPLETION REPORT**

**AMERICAN CHEMICAL SERVICE, INC.
NPL SITE
GRIFFITH, INDIANA**

MWH File No. 2090601

April 2005

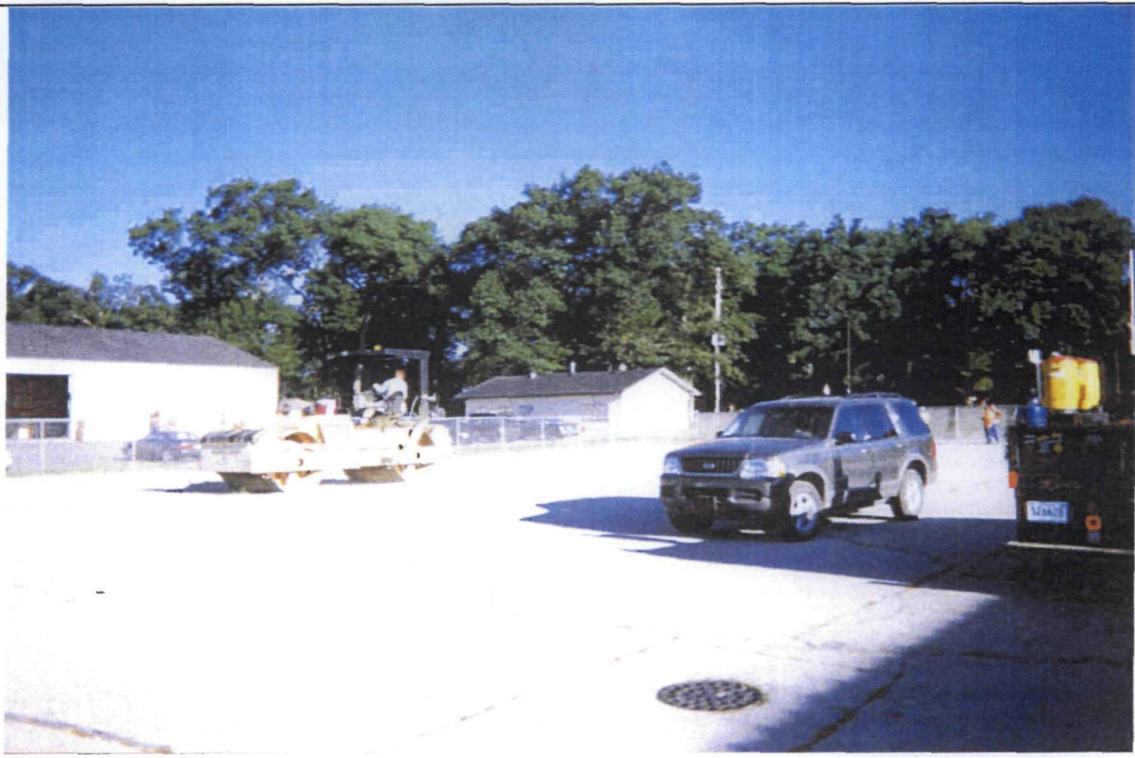
Amy Clore			
Date:			
9/7/2004			
Direction:			
Looking North West			
Comments:			
Photo 1			
Compacting pavement where test pad will be placed			
Photographer:

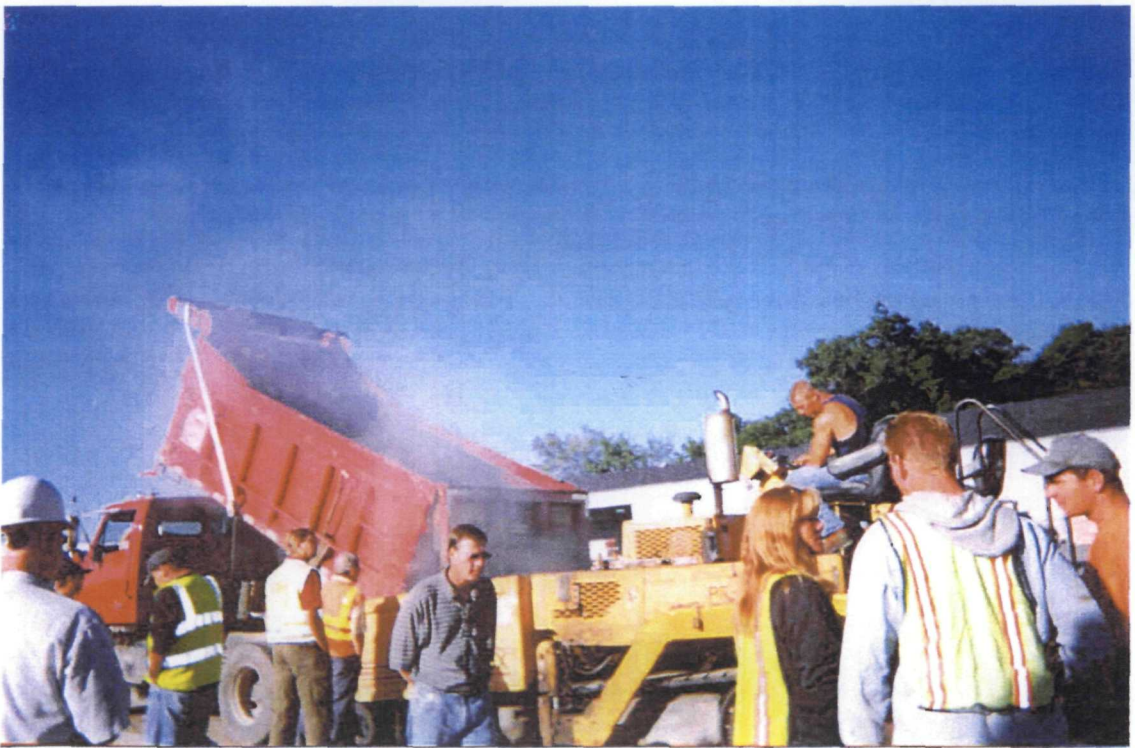
Amy Clore			
Date:			
9/7/2004			
Direction:			
Looking West			
Comments:			
Photo 2			
Truck loading paver with asphalt

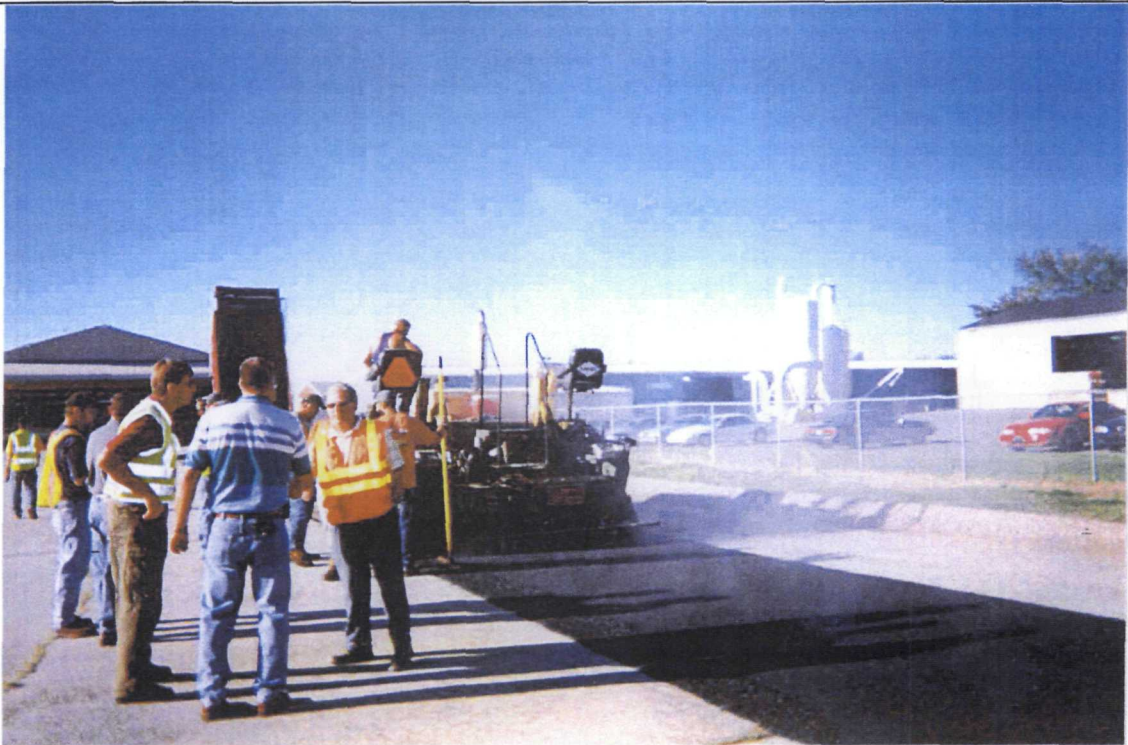
Project: ACS Final On-Site Cover	Project Number: 2090601
Site Name: American Chemical Service	Site Location: Griffith, Indiana
Photographer: Amy Clore Date: 9/7/2004 Direction: Looking South Comments: Photo 3 Paving test pad

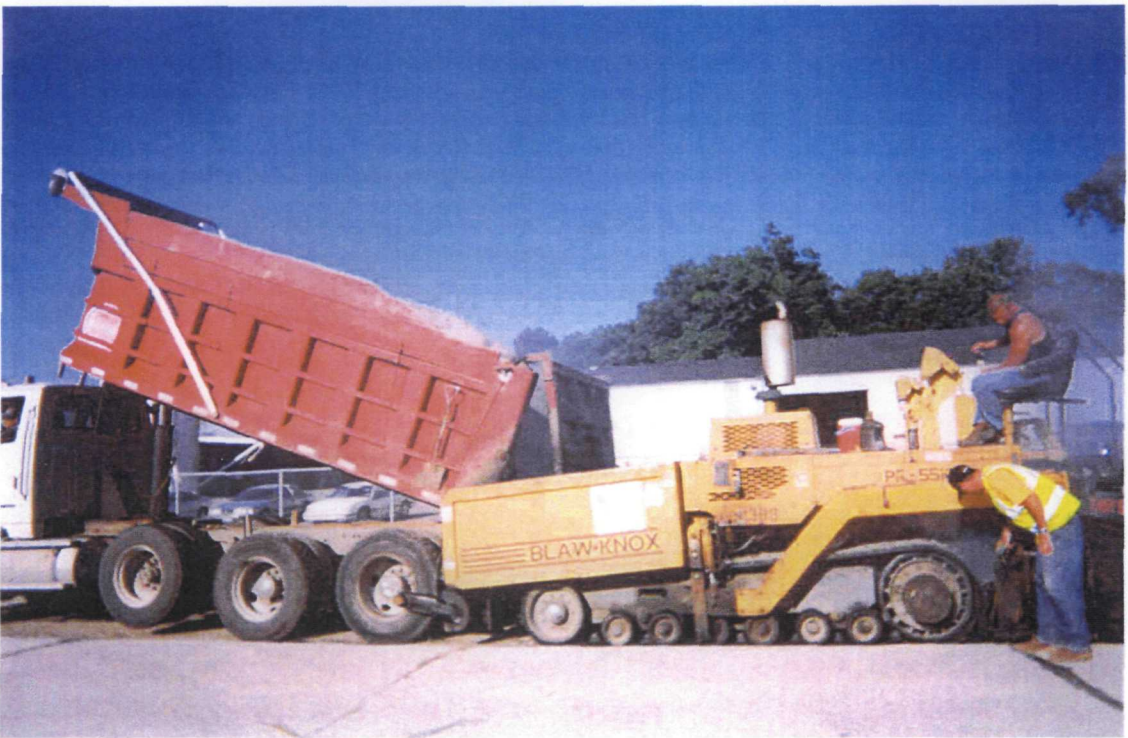
Photographer: Amy Clore Date: 9/7/2004 Direction: Looking West Comments: Photo 4 Truck reloading paver with asphalt

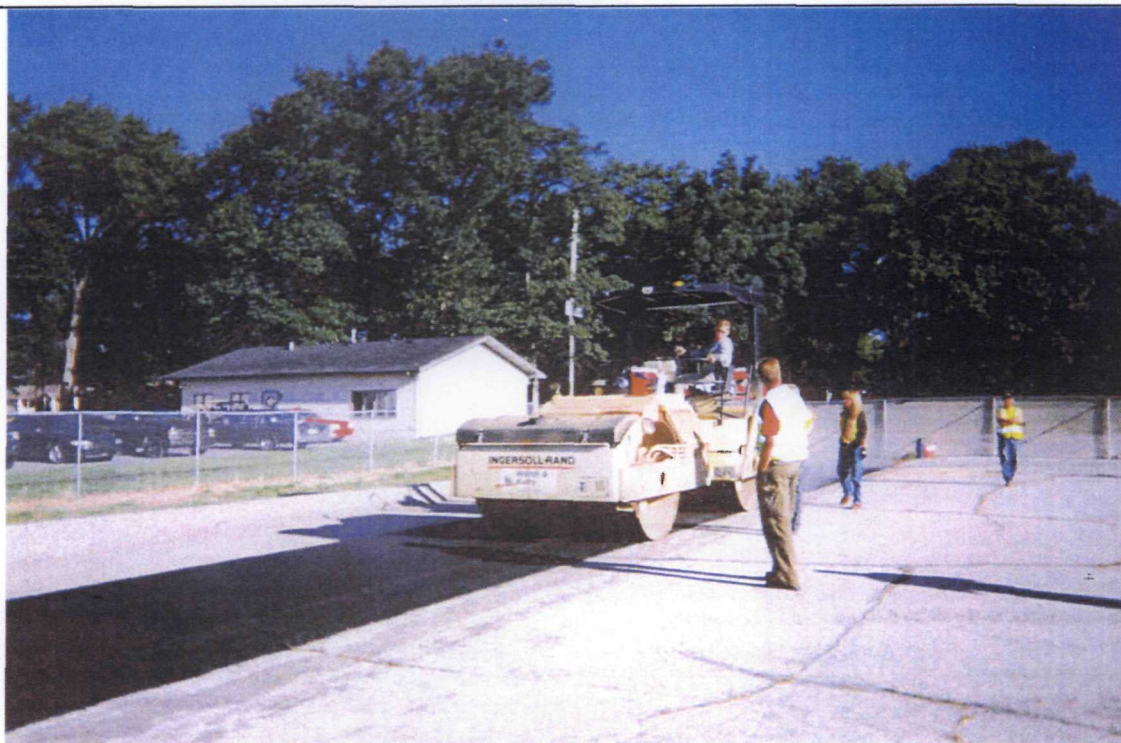
Comments:
Photo 5
Compacting first strip of test pad

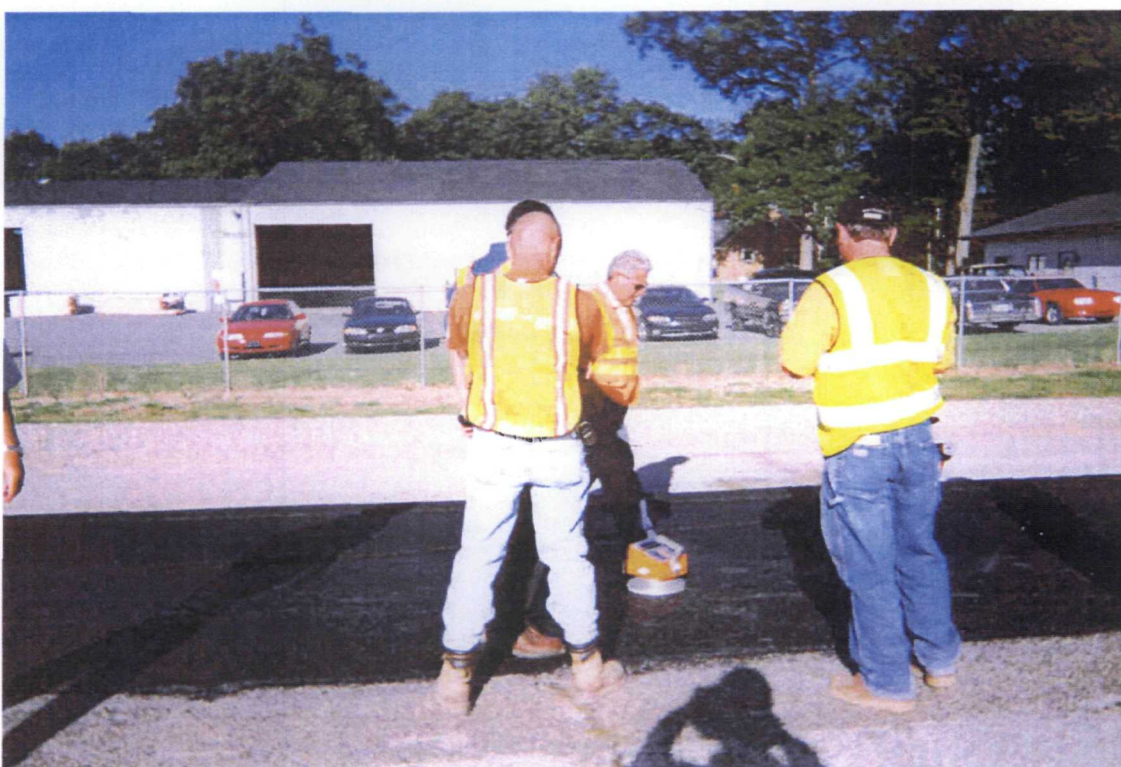
Comments:
Photo 6
Performing nuclear density tests on test pad

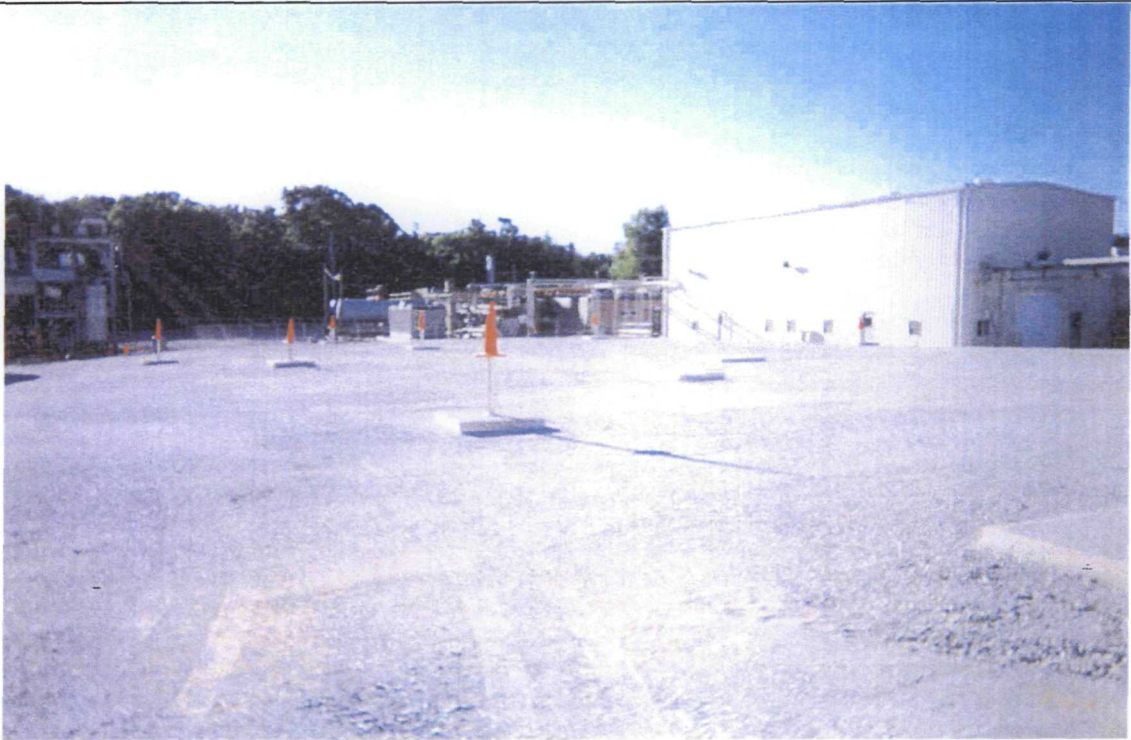
Amy Clore			
Date:			
9/8/2004			
Direction:	Looking South East		
Comments:	Photo 11 On-Site area prepped for pavement		
Photographer:

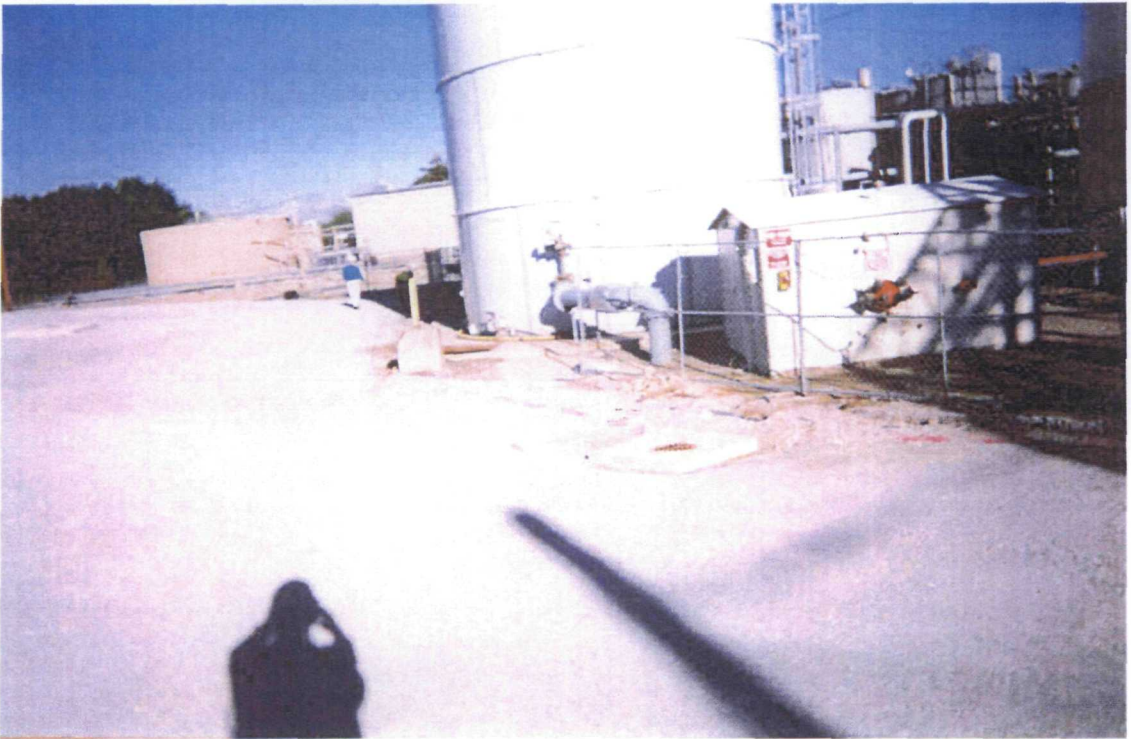
Amy Clore			
Date:			
9/8/2004			
Direction:	Looking North West		
Comments:	Photo 12 Marking cover perimeter (background), line is seen as pink dashed line (foreground)

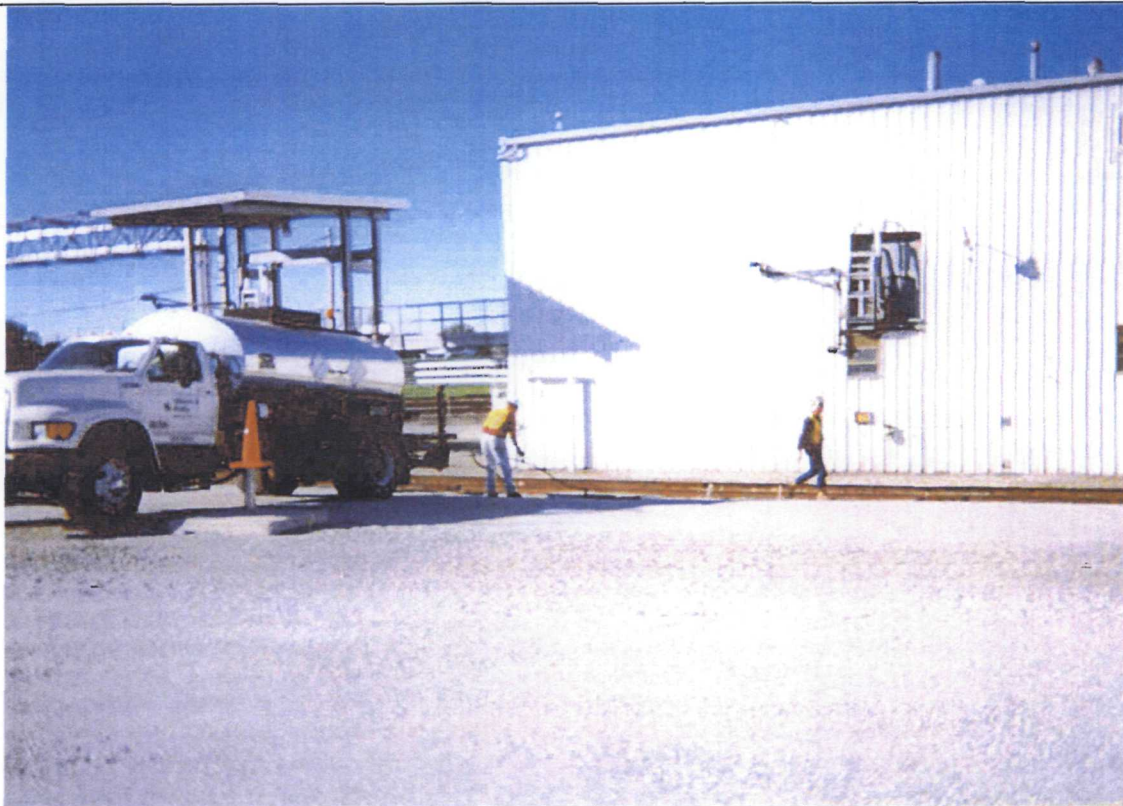
Photo 13

Spraying sealant tar
on concrete SVE
well bases

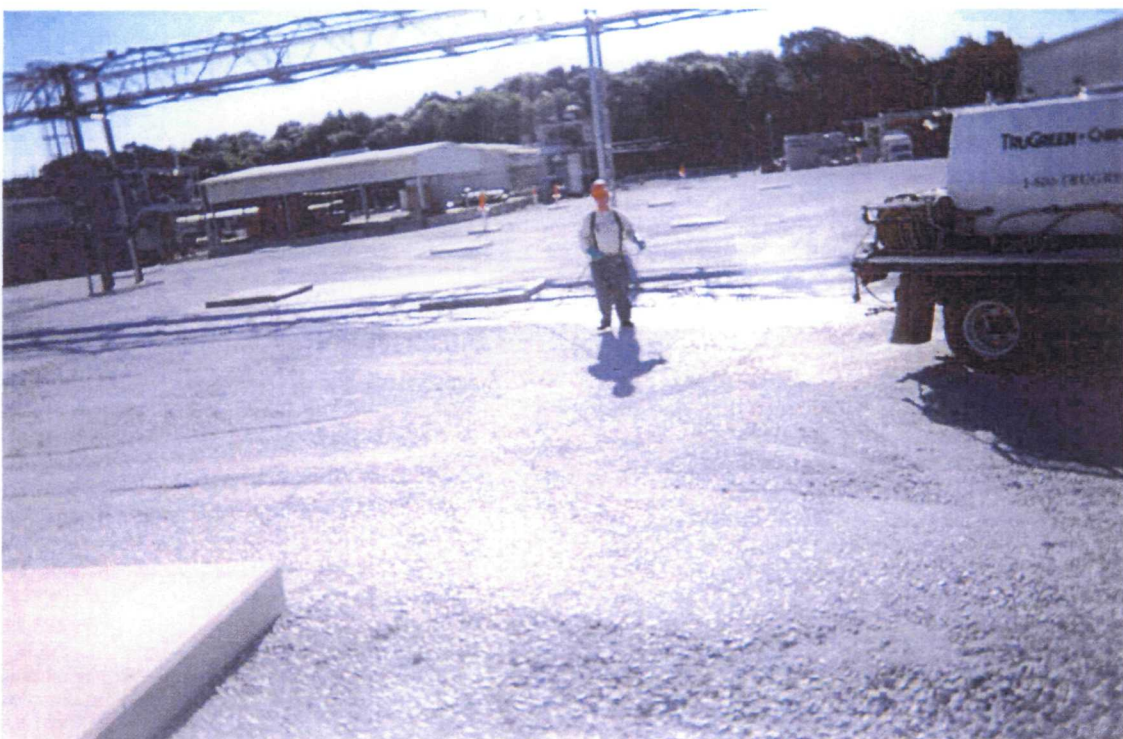
Photo 14

Herbicide application
prior to pavement
application

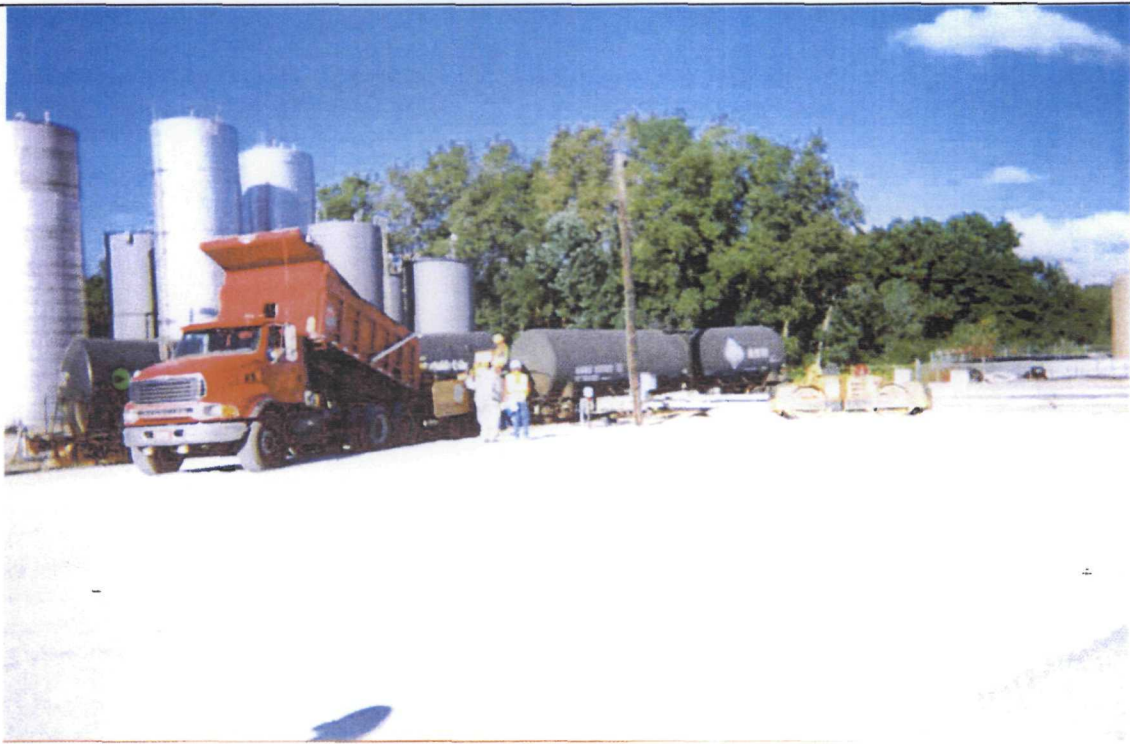
Project: ACS Final On-Site Cover	Project Number: 2090601
Site Name: American Chemical Service	Site Location: Griffith, Indiana
Photographer: Amy Clore Date: 9/8/2004 Direction: Looking West Comments: Photo 15 First truckload of asphalt loads paver on west side of On-Site cover

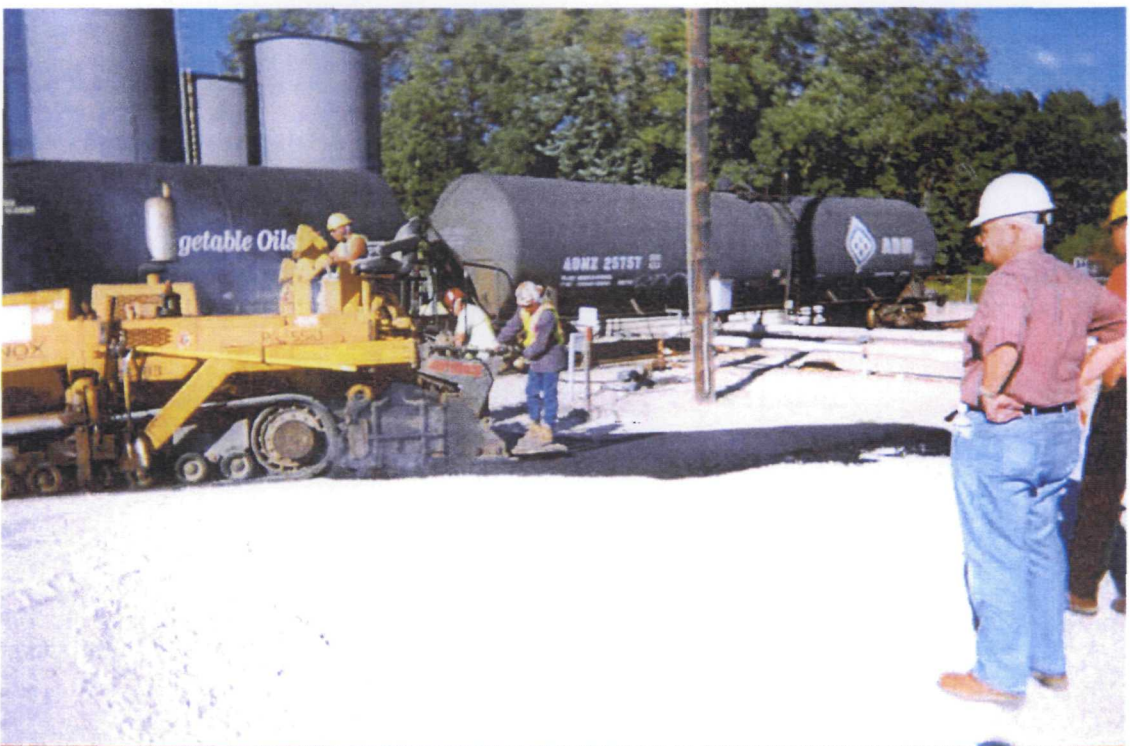
Photographer: Amy Clore Date: 9/8/2004 Direction: Looking West Comments: Photo 16 Placing pavement along the south edge of the cover area

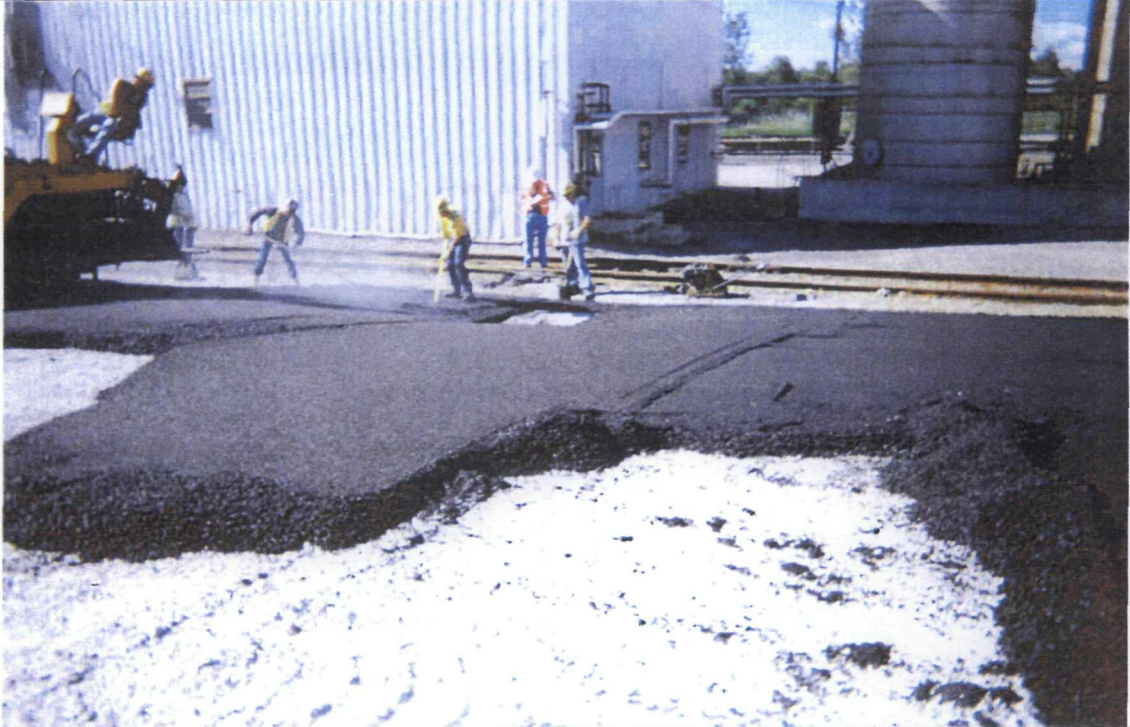
Project: ACS Final On-Site Cover	Project Number: 2090601
Site Name: American Chemical Service	Site Location: Griffith, Indiana
Photographer: Amy Clore Date: 9/8/2004 Direction: Looking South West Comments: Photo 19 Walsh and Kelly adjusting placement of asphalt with hand tools

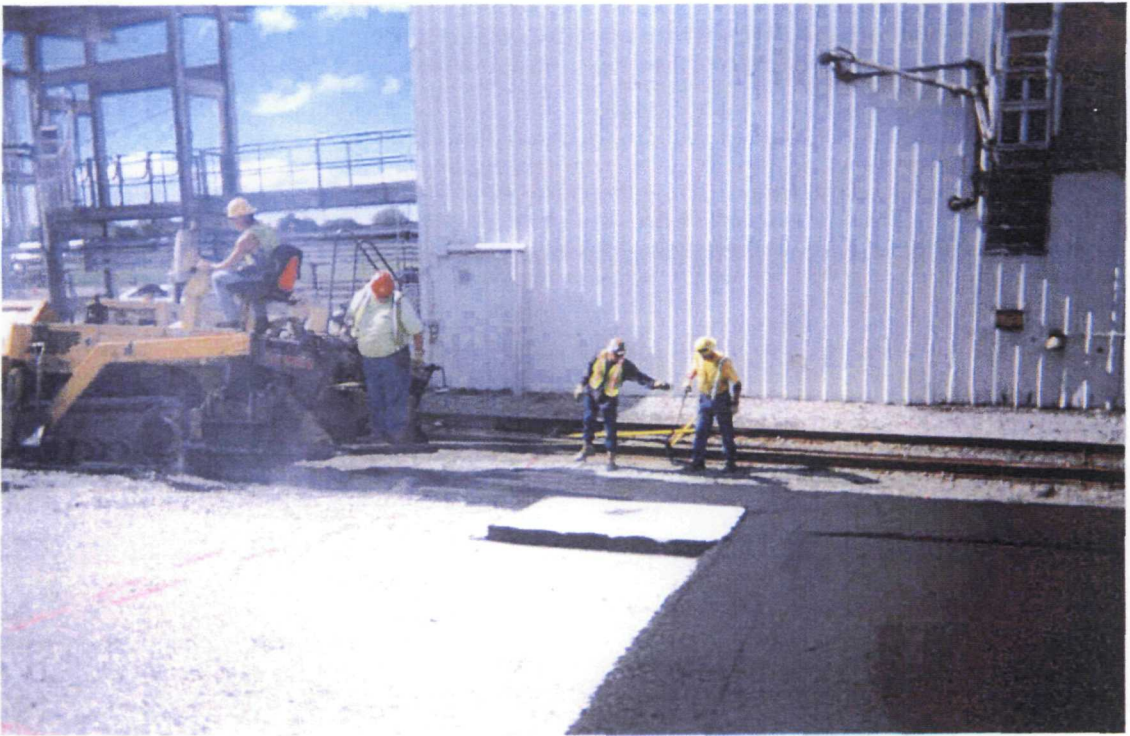
Photographer: Amy Clore Date: 9/8/2004 Direction: Looking South Comments: Photo 20 Paving around SVE well 79

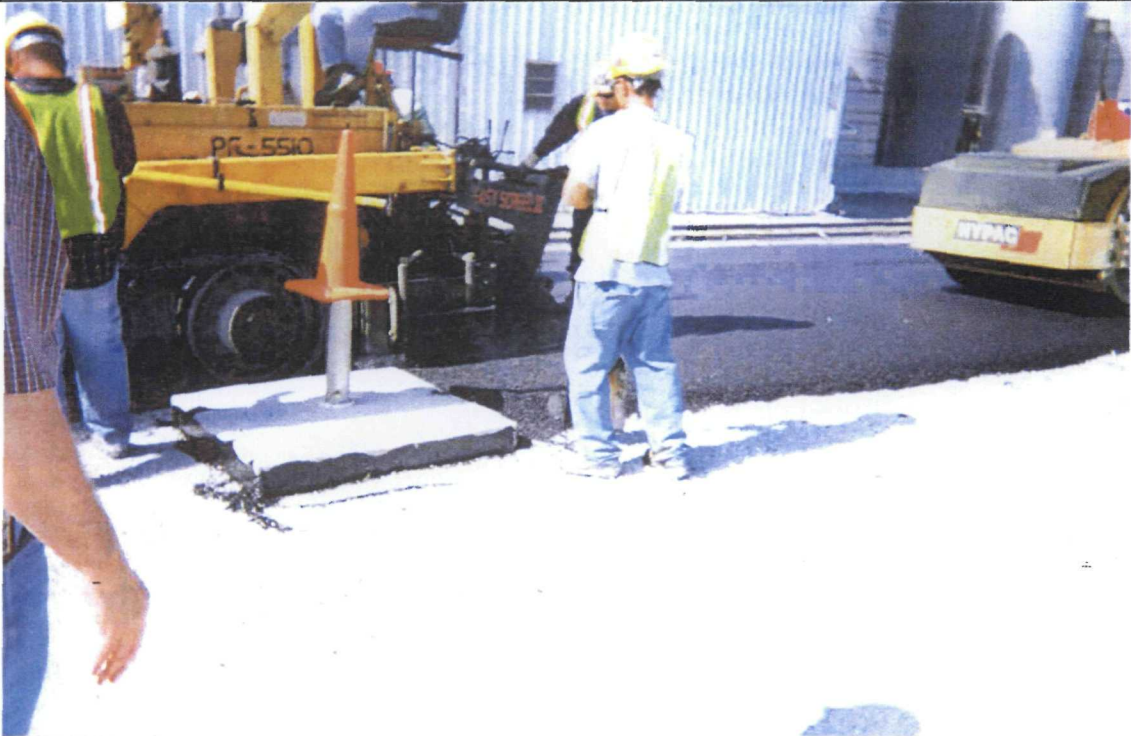
Amy Clore			
Date:			
9/8/2004			
Direction:			
Looking South			
Comments: Photo 21 Walsh and Kelly paving around an SVE well concrete base			
Photographer:

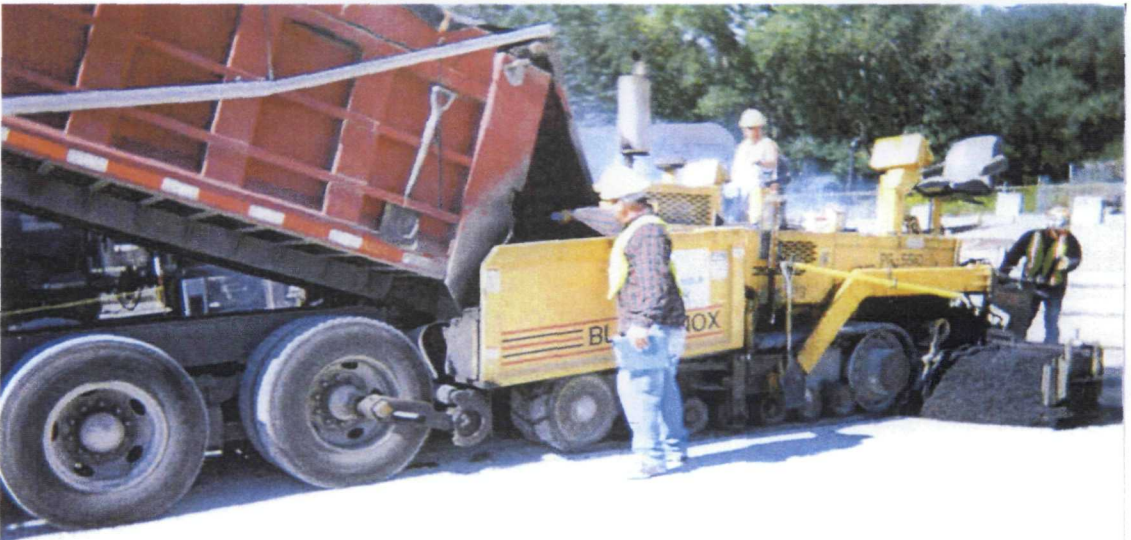
Amy Clore			
Date:			
9/8/2004			
Direction:			
Looking Southwest			
Comments: Photo 22 Taking asphalt temperature readings

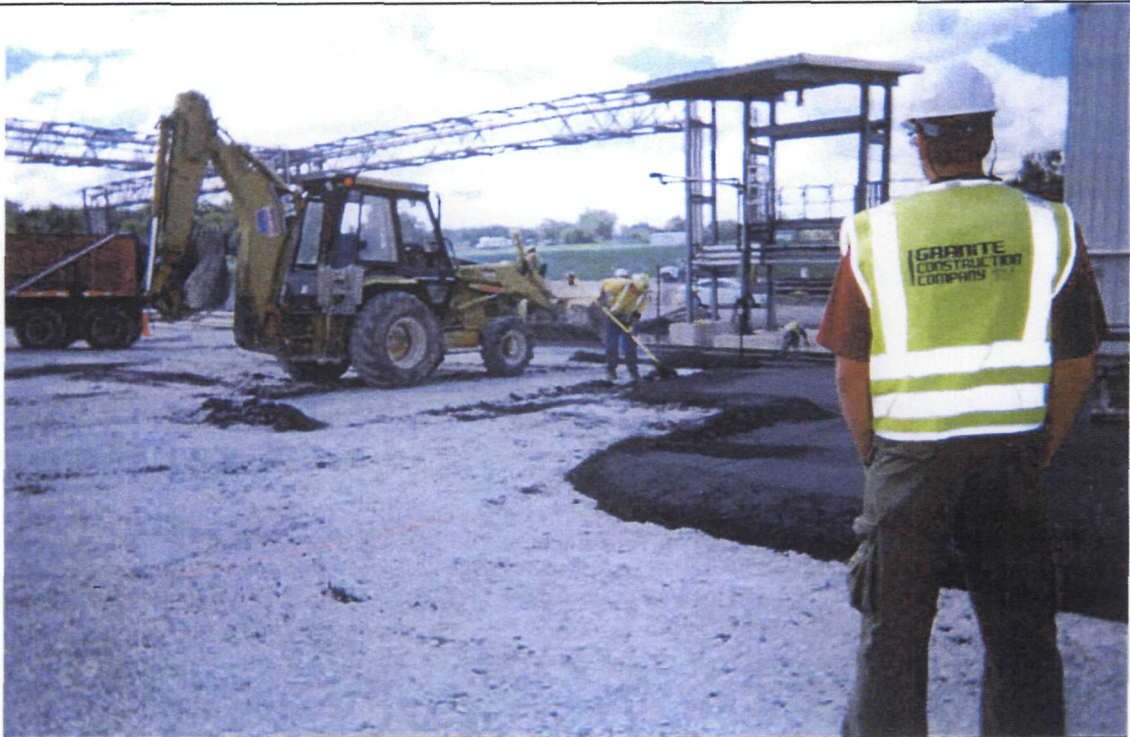
Date: 9/8/2004			
Direction: Looking South East			
Comments: Photo 23 Clearing large asphalt debris from pavement area			
Photographer: Amy Clore

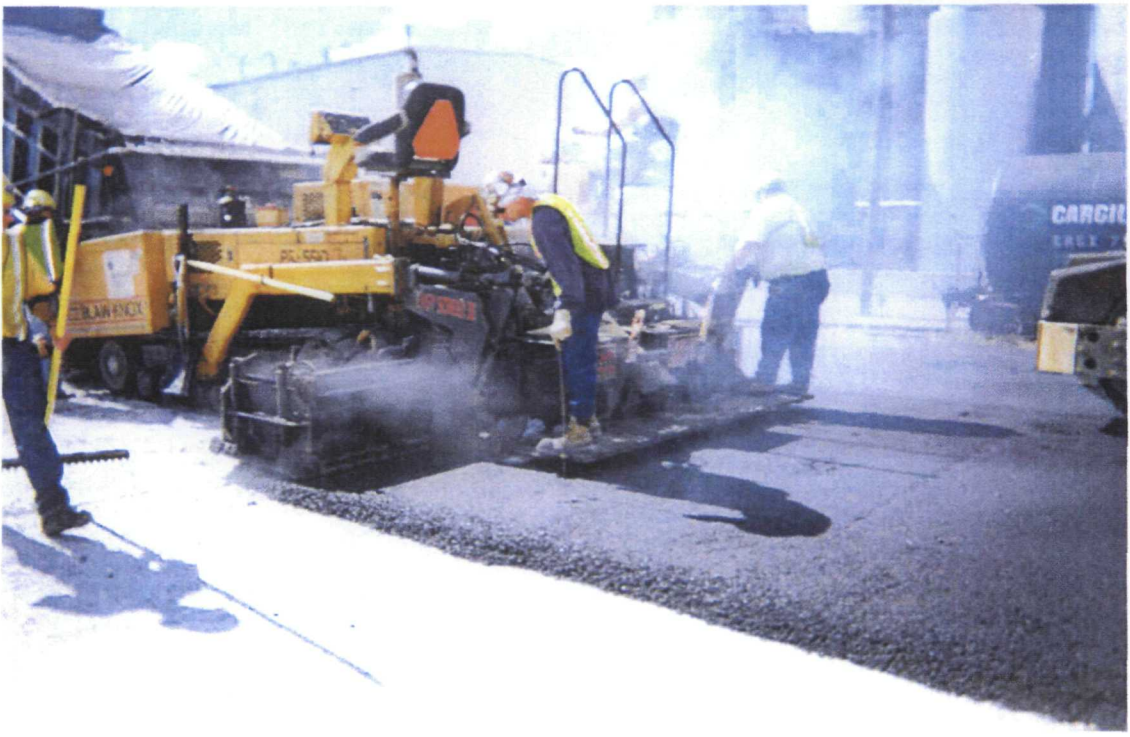
Date: 9/8/2004			
Direction: Looking South			
Comments: Photo 24 Verifying pavement depth with rod while paving

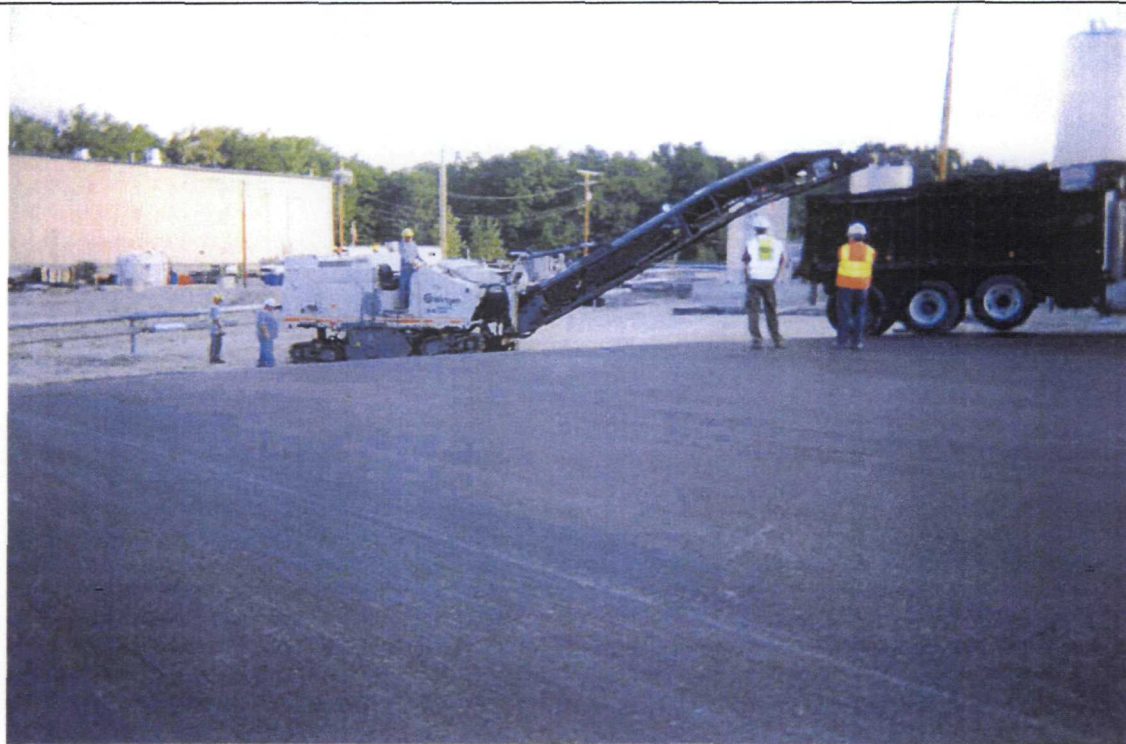
Comments:
Photo 25
Grinding cold joint
from first day of
paving

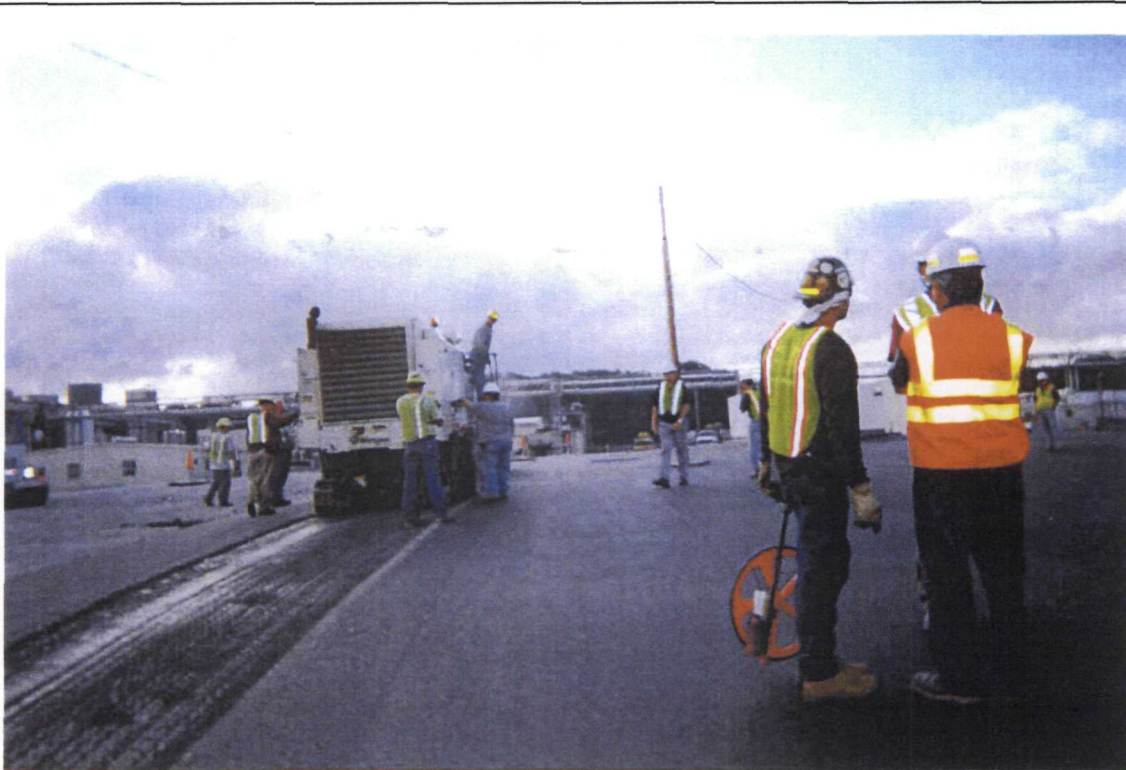
Comments:
Photo 26
Rear view of joint
grinding equipment

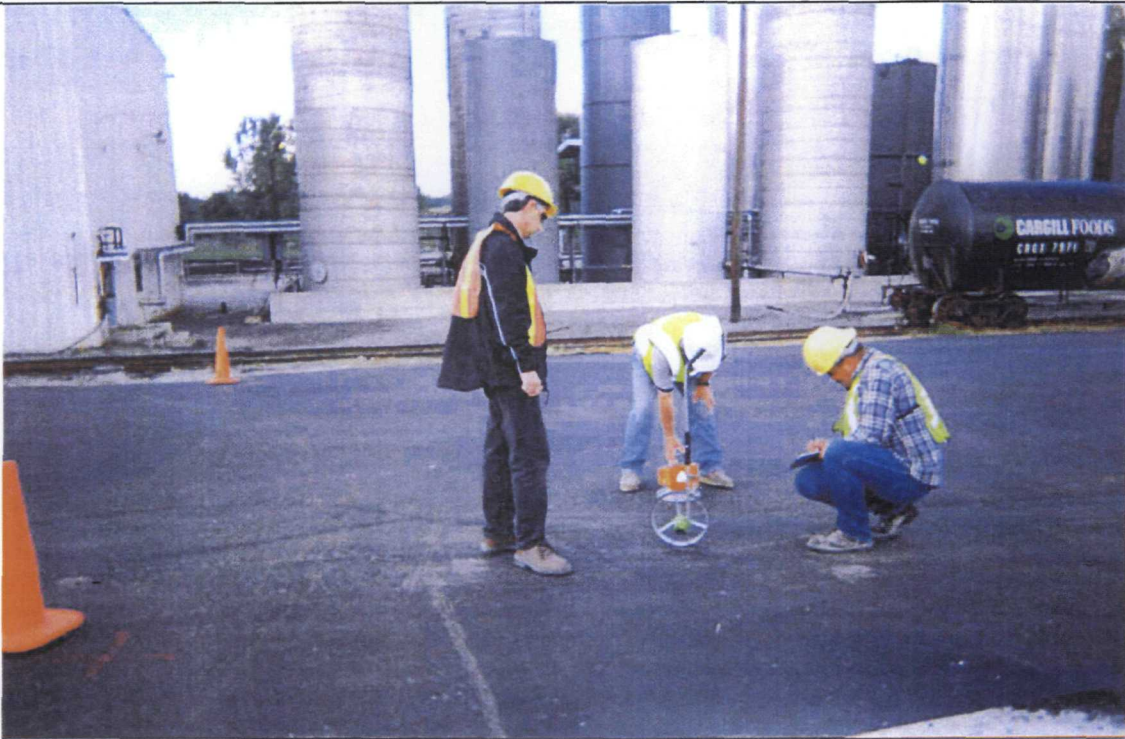
Amy Clore			
Date:			
9/9/2004			
Direction:			
Looking South West			
Comments:			
Photo 27			
Independent QC contractor performing in-place density tests of September 8 th s pavement			
Photographer:

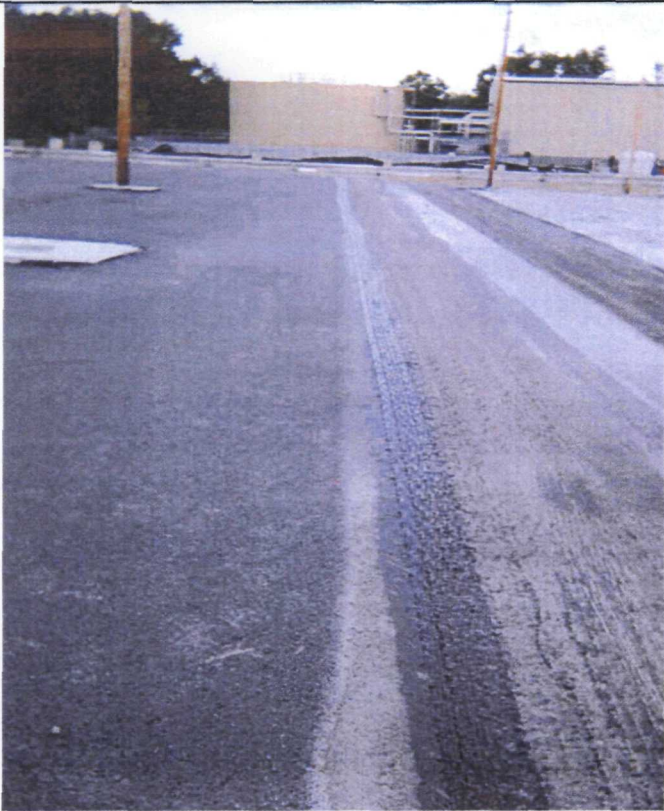
Amy Clore			
Date:			
9/9/2004			
Direction:			
Looking North West			
Comments:			
Photo 28			
Grinded joint with wet sealant visible along edge

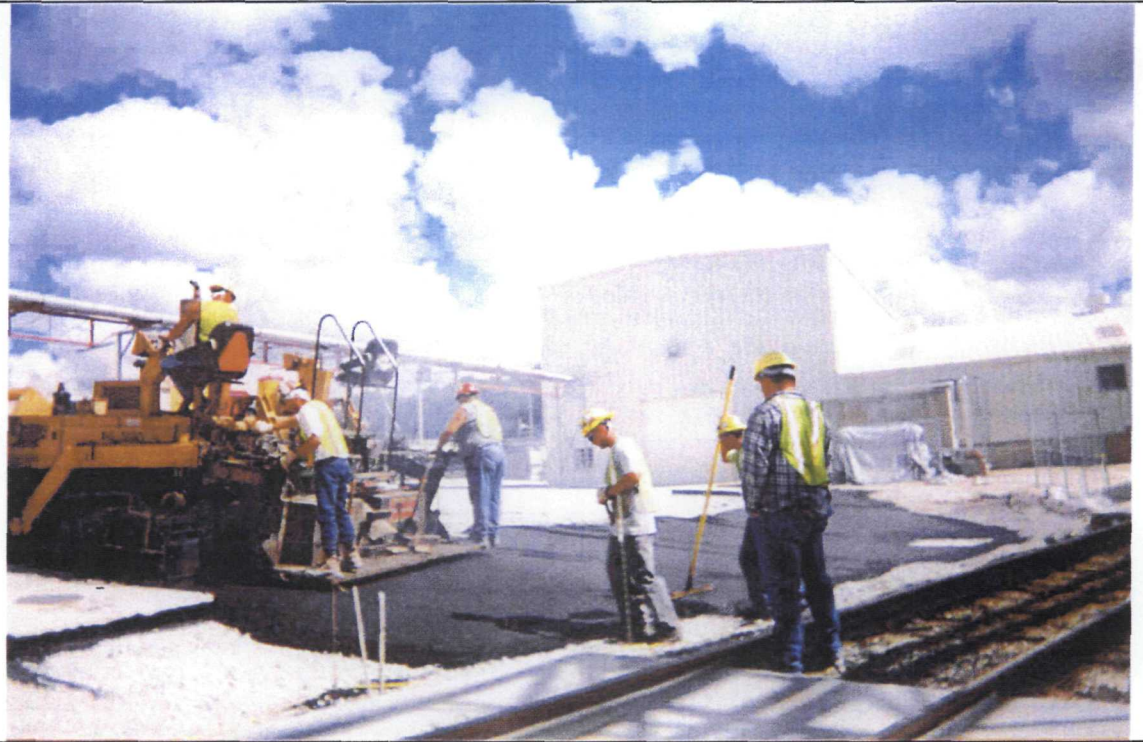
Photo 29

Paving sloped
perimeter on south
side of SBPA area

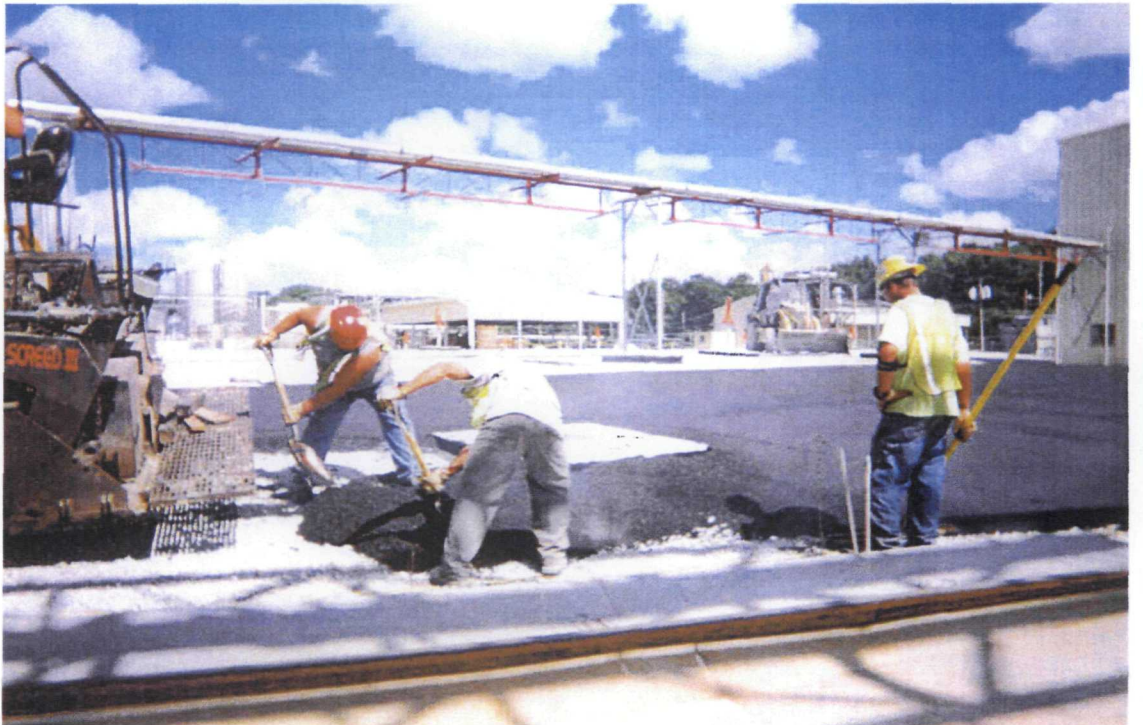
Photo 30

Placing asphalt
pavement by hand
around SVE well 84

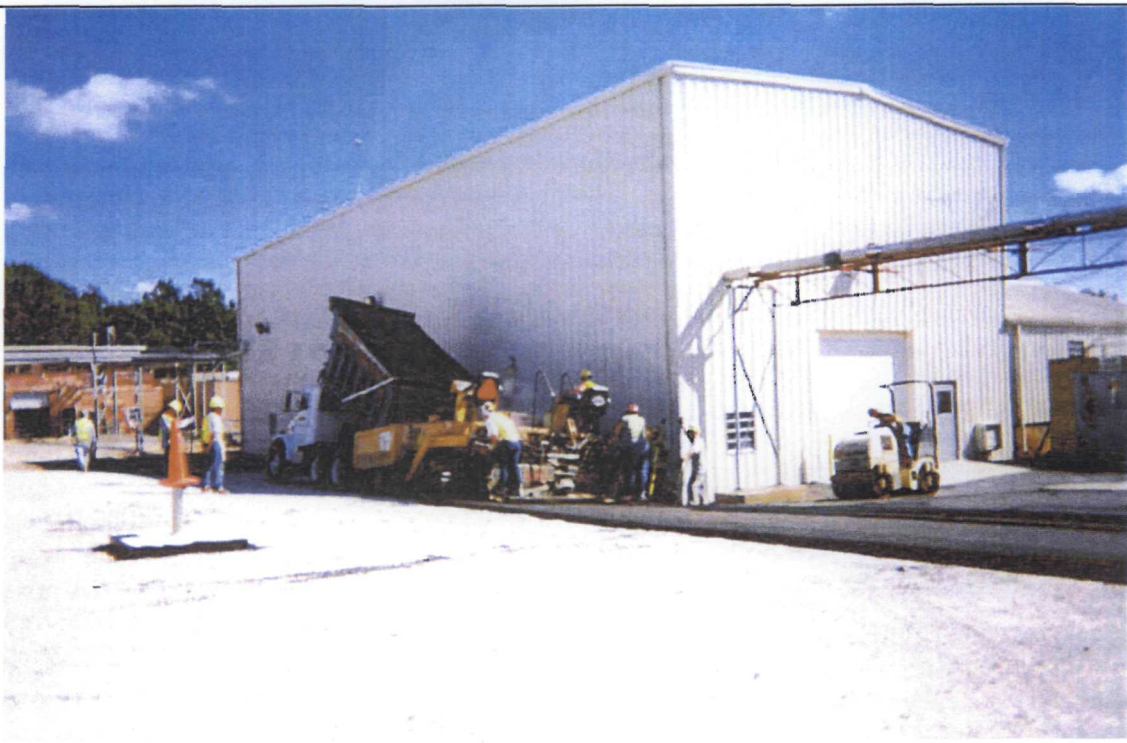
Project: ACS Final On-Site Cover		Project Number: 2090601	
Site Name: American Chemical Service		Site Location: Griffith, Indiana	
Photographer: Amy Clore Date: 9/9/2004 Direction: Looking East Comments: Photo 31 Walsh and Kelly paving alongside perimeter on south east side on On-site area

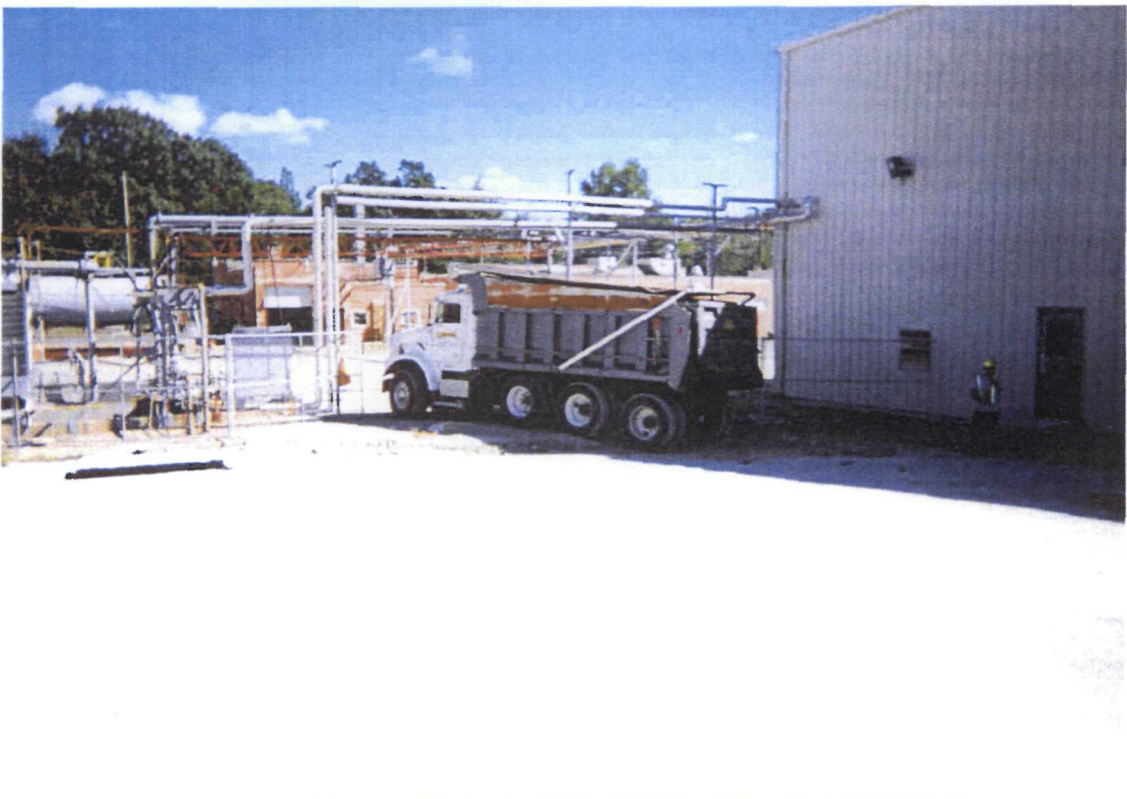
Photographer: Amy Clore Date: 9/9/2004 Direction: Looking East Comments: Photo 32 Asphalt truck utilizing ACS perimeter gate as exit route

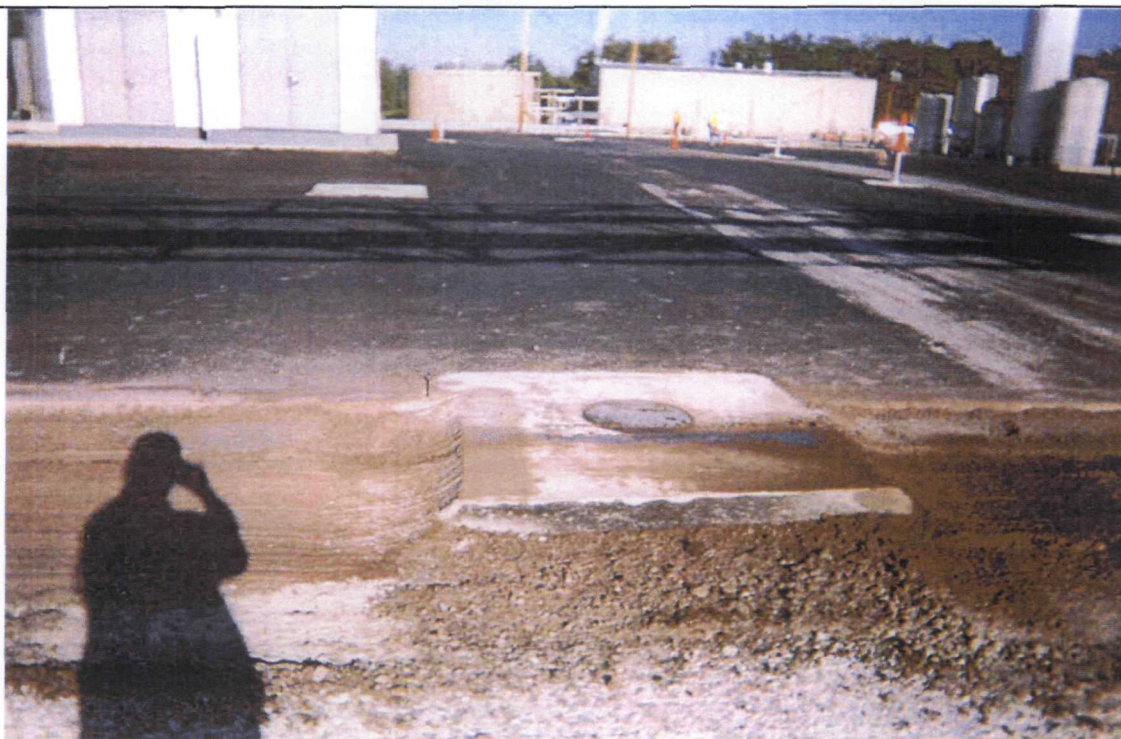
Photo 33

Concrete pad at
SVE 62 after it has
been prepared for
placement of asphalt
